Access Building Inspection

Summary

Property address: **14021 Some Road, Anytown, CA90650**

Inspection date: **Sunday, May 12, 2013**

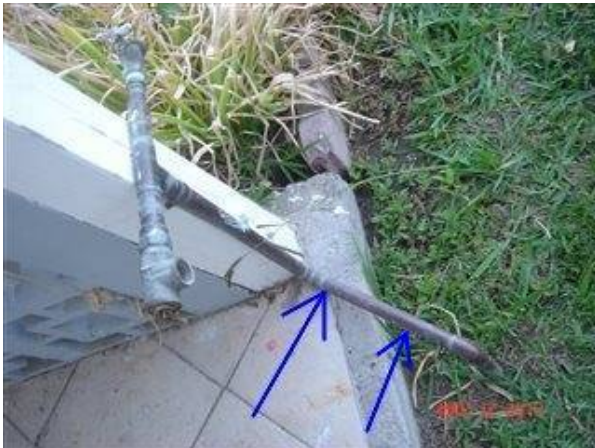
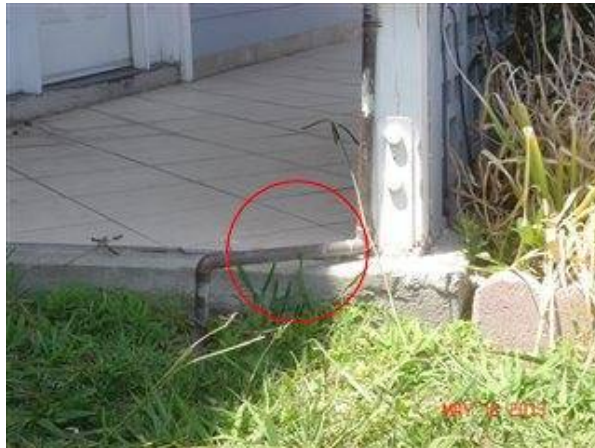
trip hazards: The water pipe is above the ground, it has a trip hazard.

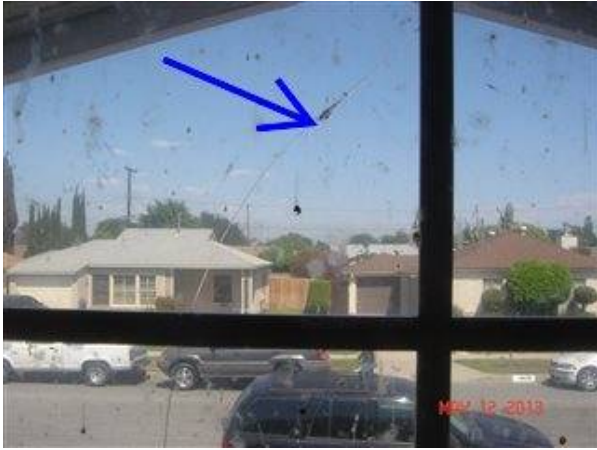
Photo 4

- 6) 🛠️ Fornt porch: The fixed window has a cracks glass need to replace.

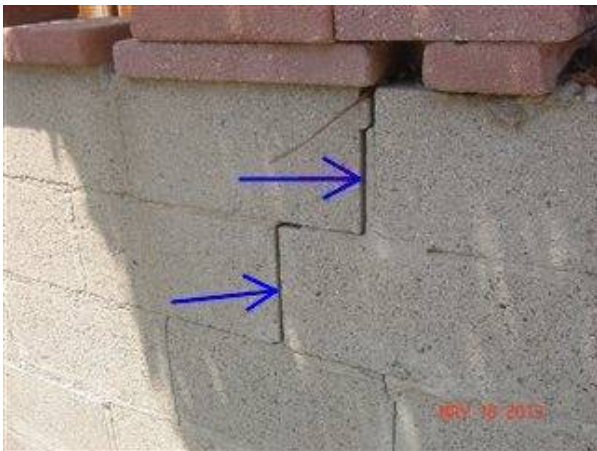
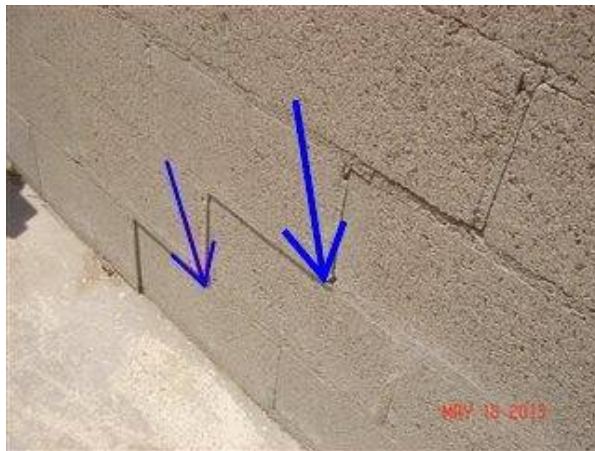
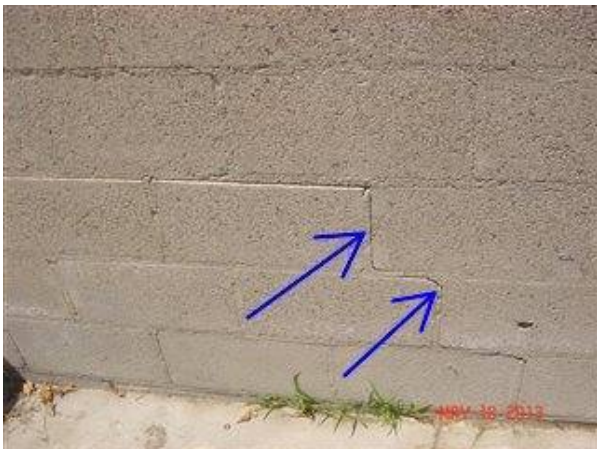
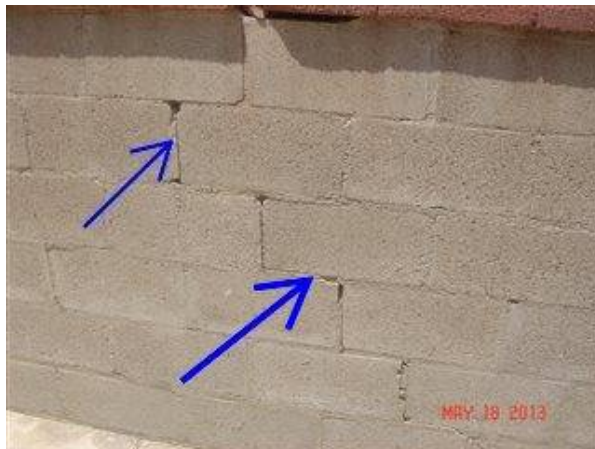
- 7) 🔍 Concrete masonry block walls are installed as fencing. Wrought Iron is installed as fencing. The fencing and / or wall needs to be repaired. Some pointing is needed. There is placing mortar into joints to correct defects or completely fill the joints between bricks or CMU's.

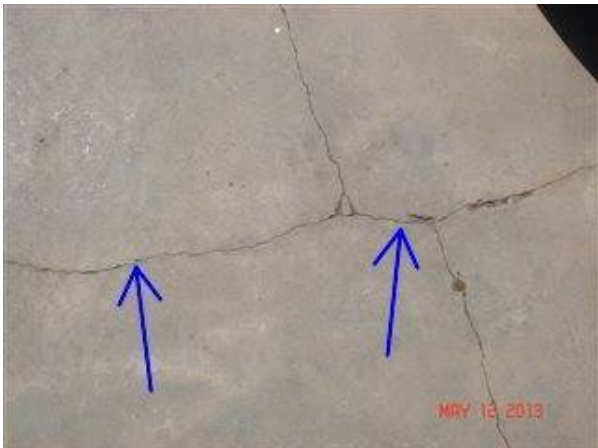
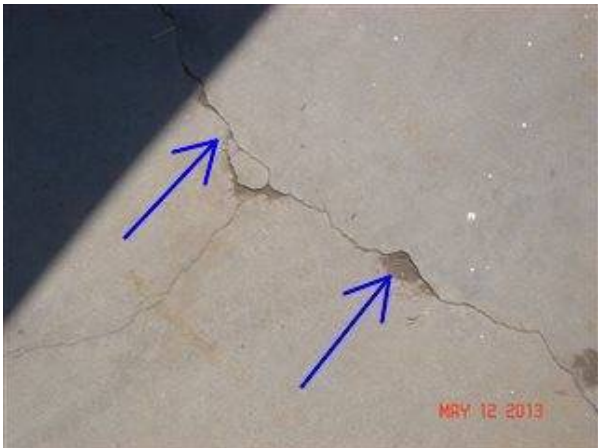
- 8) 🛠️ ⓘ Minor deterioration (e.g. cracks, holes, settlement, heaving) was found in the

driveway, but no trip hazards were found. The client may wish to have repairs made for cosmetic reasons.

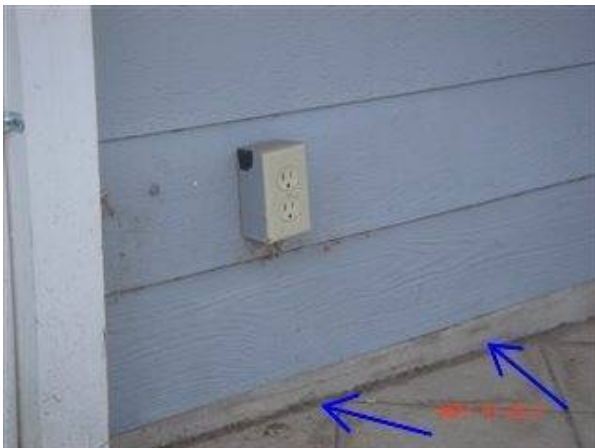
Photo 47

Untreated wood siding and/or trim was in contact with concrete or masonry at the exterior. Moisture collected between the two materials or wicking up into the wood is a conducive condition for wood-destroying organisms. Wood siding or trim should be installed with a minimum clearance of 1-2 inches between it and concrete or masonry below it at building exteriors. Monitor these areas for rot or infestation in the future and repair if needed. Recommend that a qualified person repair per standard building practices. For example, by trimming siding or trim as needed.

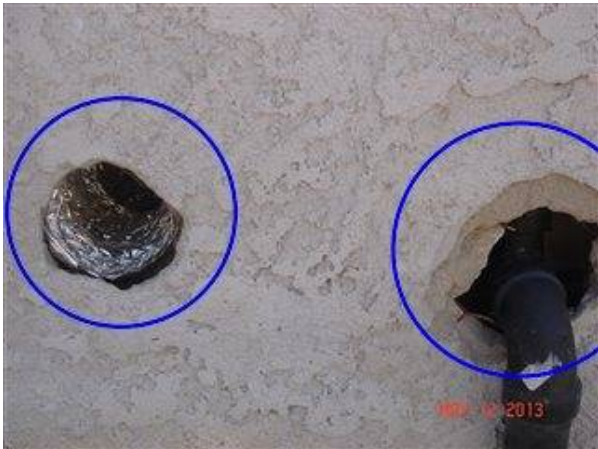
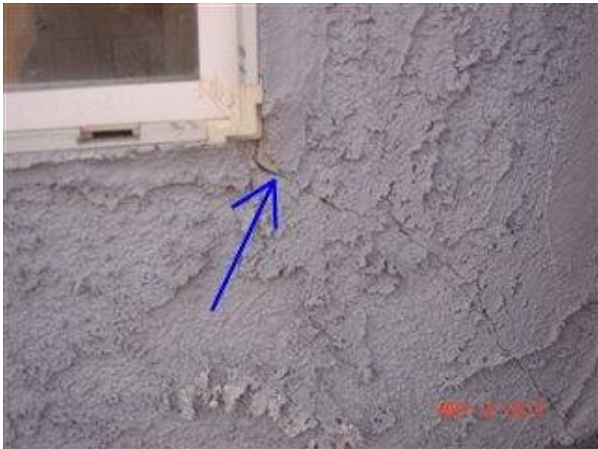
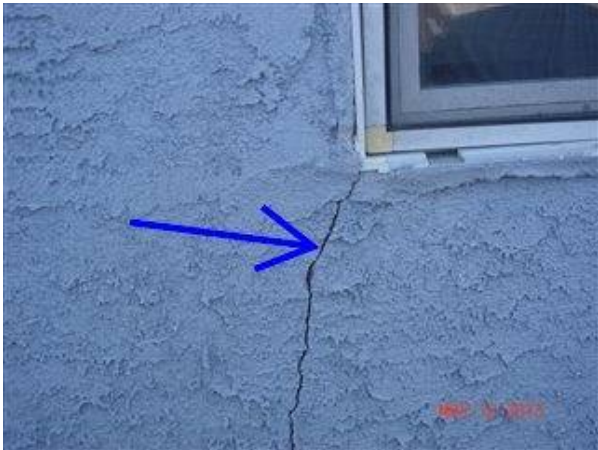
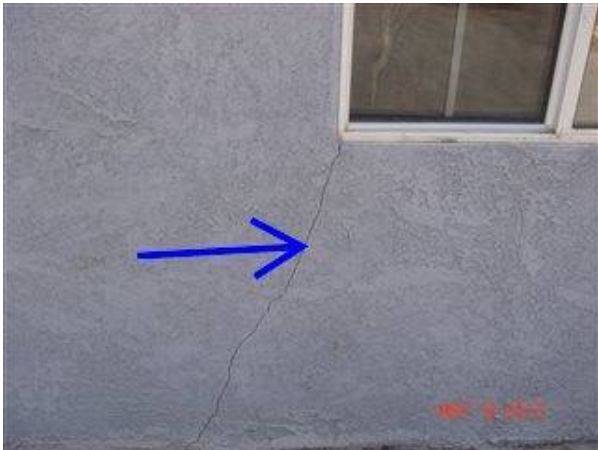
Cracks, deterioration and/or damage were found in one or more areas of the exterior stucco finish. In damp climates, moisture may enter cracks or damaged areas and further deteriorate the stucco. Also the wall behind the stucco may become damaged from moisture. Note that areas behind the stucco are inaccessible and excluded from this inspection. Recommend that a qualified contractor repair or replace stucco as necessary.

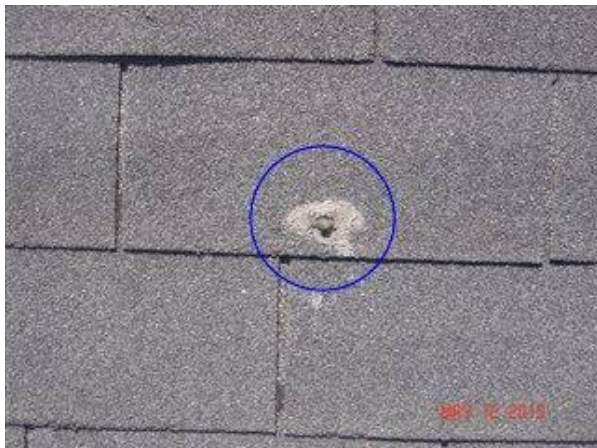
Photo 5

One or more roofing nails weren't fully seated and shingles were lifting or nail heads were protruding through shingle surfaces. The nails may have loosened, or were not pounded in fully when installed. Shingles are likely to be wind damaged, and leaks can occur as a result. This is a conducive condition for wood-destroying organisms. Recommend that a qualified contractor repair as necessary. For example, by replacing shingles.

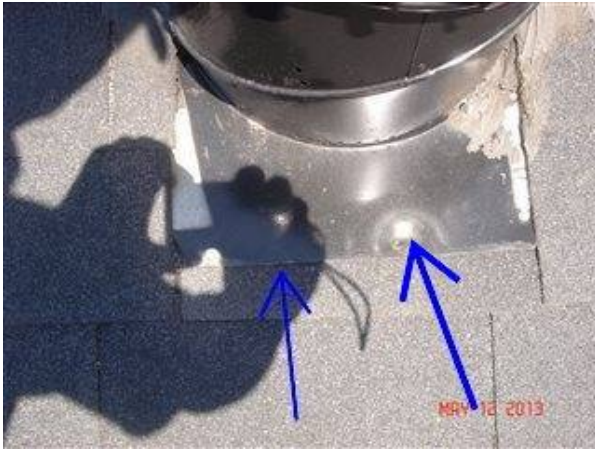
Photo 7

Condition of Roof Covering Vent:
Service Recommended. Improperly installed vent boot on roof at Northeast nailed directly to shingles, creating entry points for water and stressing boot. Recommend evaluation by licensed, qualified roofing contractor.

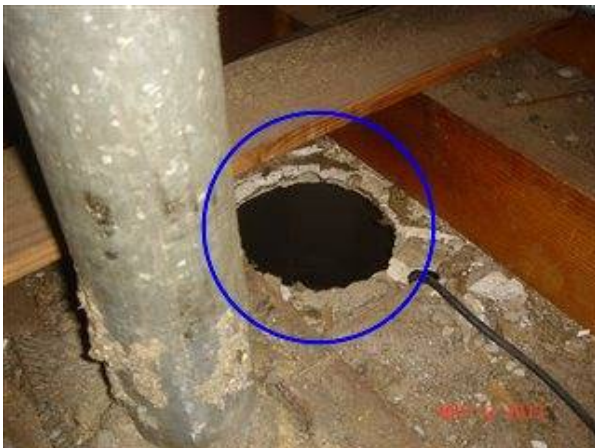
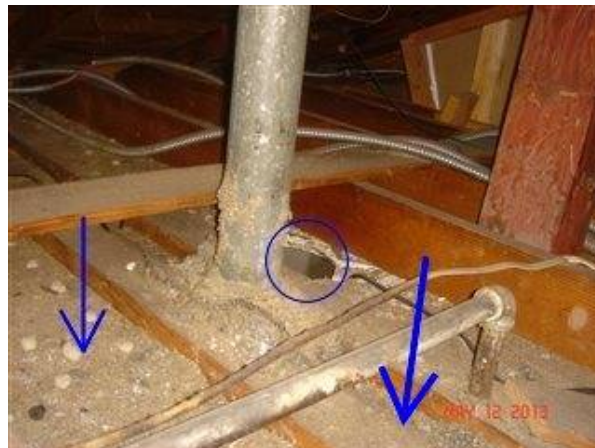
15) 🔧🔍 Attic exhaust vent: Service recommended. two axhaust vents aren't through roof.

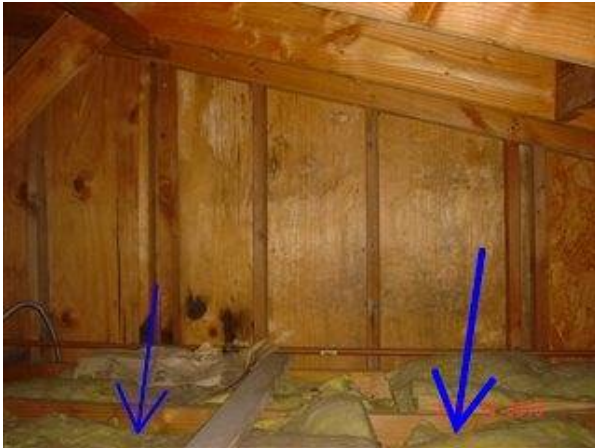
Photo 26

16) 🔧🔍 No vapor retarder was visible in the attic. Such vapor retarders reduce the flow of moisture from living spaces below, up into the attic, and prevent damage from moisture. For example, fungal rot, mold, and ice dams on the roof. Vapor retarders are not a standard recommendation except for very cold regions and in cases where there is high humidity in the

house during the winter. Based on conditions found during this inspection, recommend that a qualified contractor install a vapor barrier.

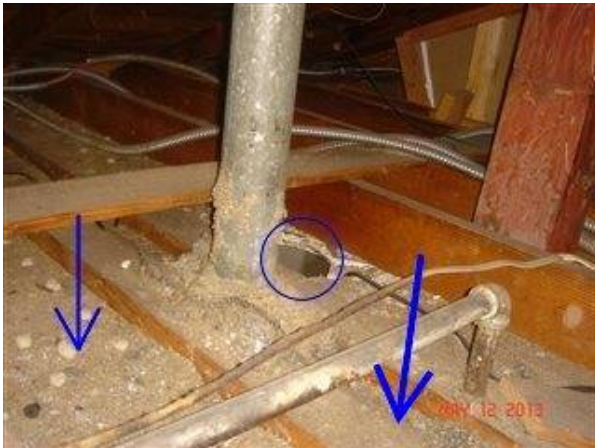
Photo 28

19) Attic Insulation: Service Recommended. Some attic area is lack of insulation .

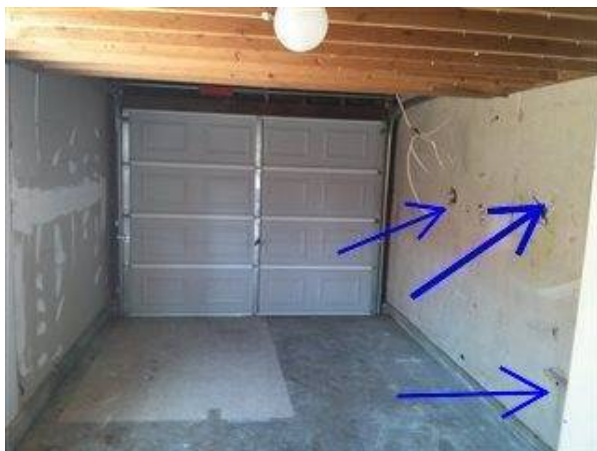
Photo 135

Interior Wall: Service recommended

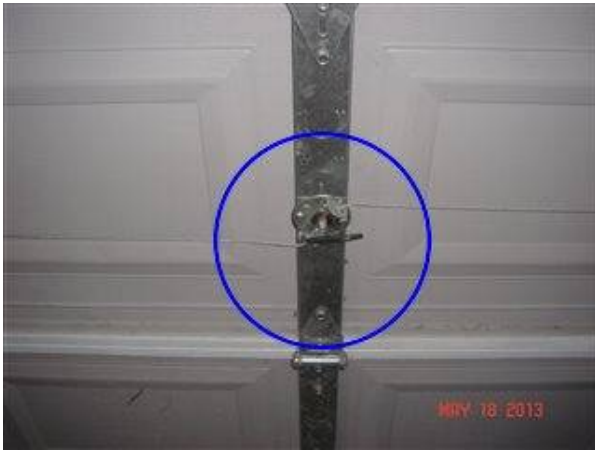
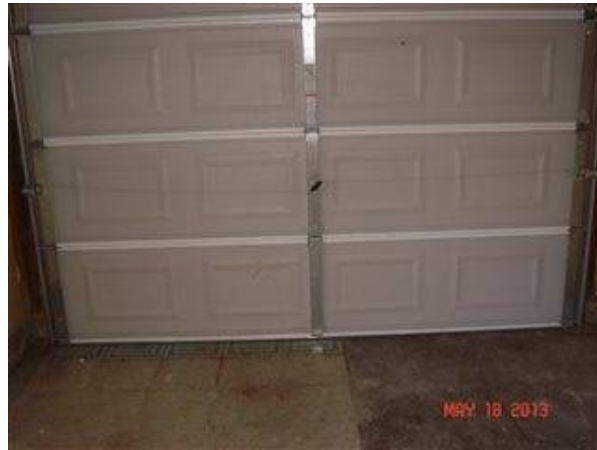
The lock mechanism on one or more garage vehicle doors was inoperable or difficult to operate. Recommend that a qualified person repair as necessary so the door(s) can be easily secured.

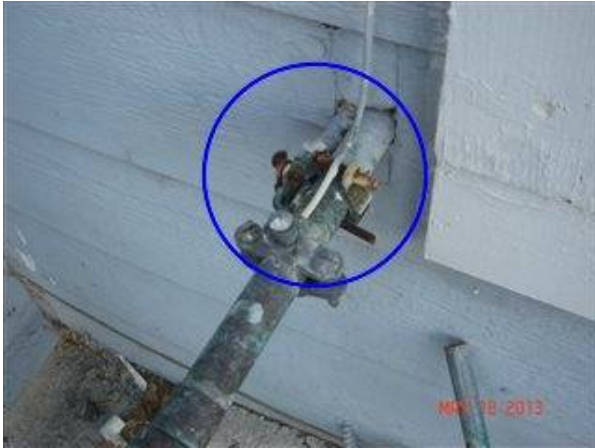
Photo 35

One or more clamps that secure the electric service's grounding electrode conductor(s) to a were corroded. Grounding may be substandard as a result and may be a safety hazard for shock. Recommend that a qualified electrician repair as necessary. For

example, by tightening clamps.

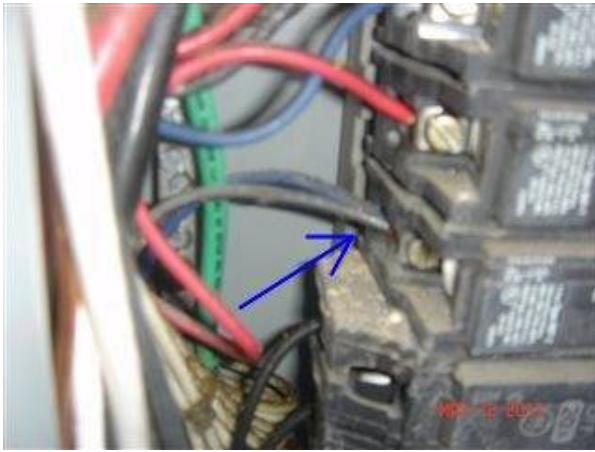
Photo 32

A double tap is observed in main panel.
This may cause the circuit breaker improperly trip.
Recommend repair by a licensed and insured electrical contractor..

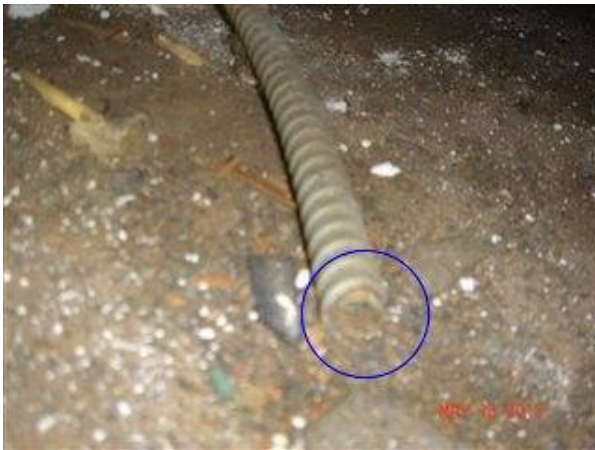
Photo 13

Bare wire ends, or wires with a substandard termination, were found at one or more locations. This is a potential shock hazard. Recommend that a qualified electrician repair as necessary. For example, by cutting wires to length and terminating with wire nuts in a permanently mounted, covered junction box.

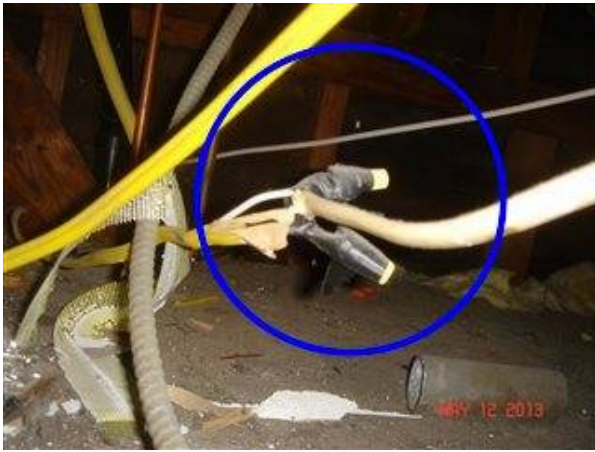
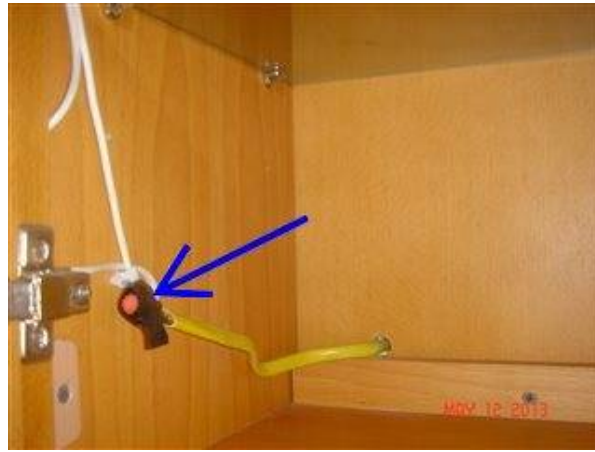
Wire splices were exposed and were not contained in a covered junction box. This is a potential shock or fire hazard. Recommend that a qualified electrician repair per standard building practices. For example, by installing permanently mounted junction boxes with cover plates where needed to contain wiring splices.

Kitchen Cabinet Lighting: Improperly terminated (only capped) hot (assumed) electrical wire in the cabinet. This may cause a shock hazard. Recommend repair by a licensed and insured electrical contractor.

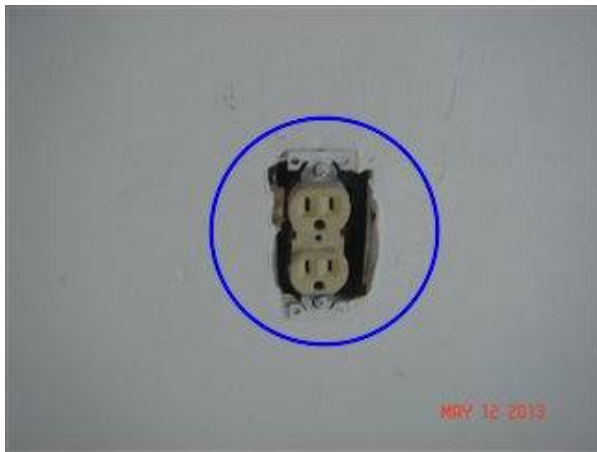
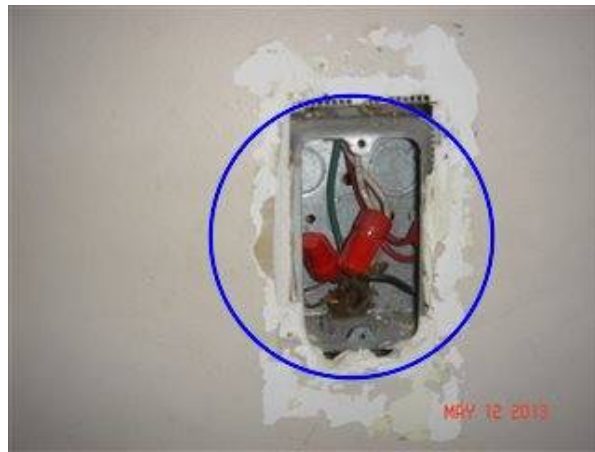
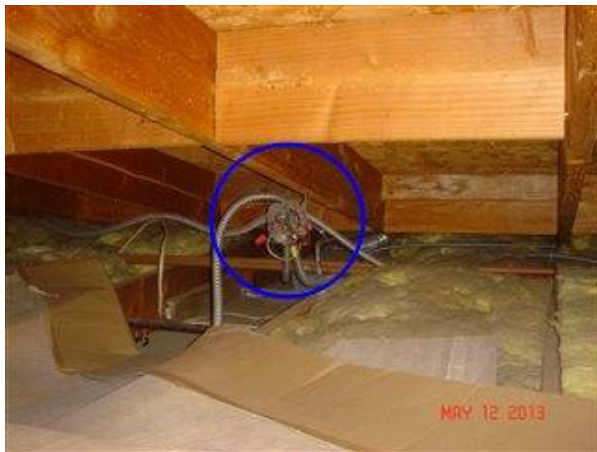
One or more cover plates for switches, receptacles (outlets) or junction boxes were missing or broken. These plates are intended to contain fire and prevent electric shock from occurring due to exposed wires. Recommend that a qualified person install cover plates where necessary.

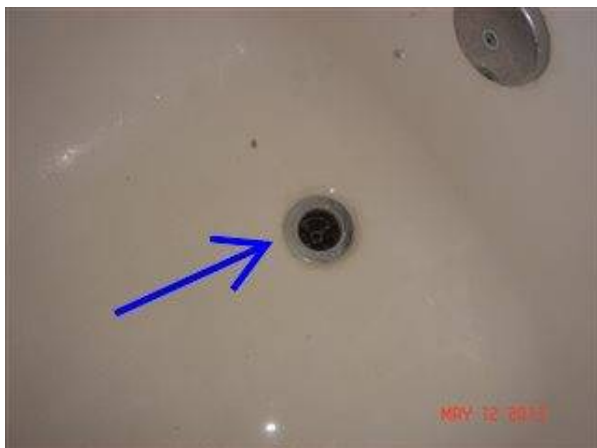
Photo 19

The sink drain stopper mechanism at location(s) #A, D, E, F was missing. Recommend that a qualified person repair or replace as necessary.

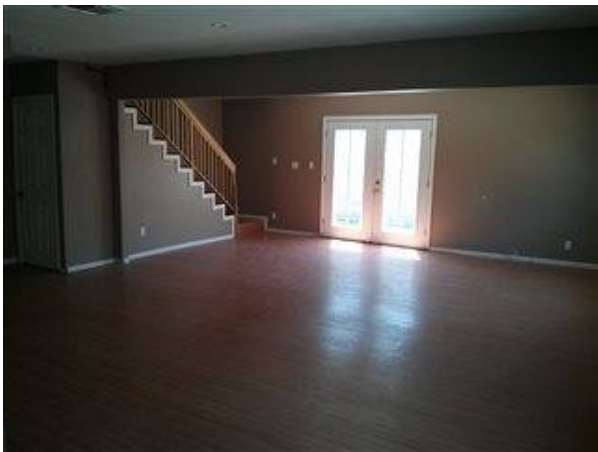
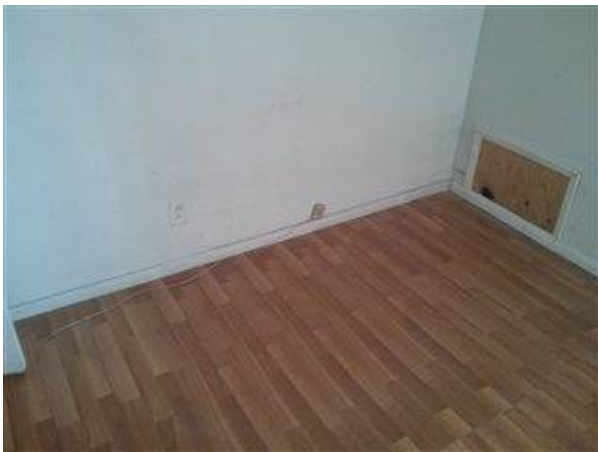
Squeaking or creaking noises occur when walking on one or more sections of flooring. This is usually caused by substandard construction practices where the sub-floor decking is not adequately fastened to the framing below. For example, not enough glue was used and/or nails were used rather than screws. In most cases, this is only an annoyance rather than a structural problem. Various solutions such as [Squeeeeeek No More and Counter Snap fasteners](#) exist to correct this. Repairs to eliminate the squeaks or creaks may be more or less difficult depending on the floor covering and the access to the underside of the sub-floor. Recommend that a qualified contractor evaluate and repair as necessary. For more information, visit:

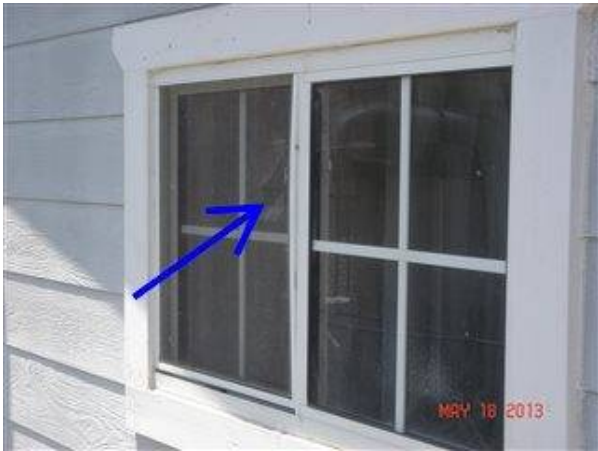
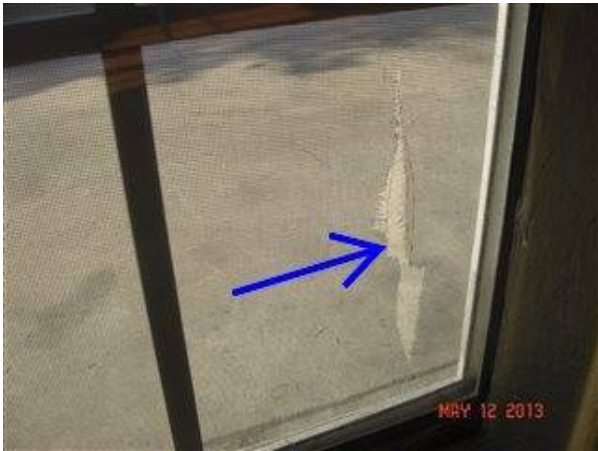
One or more window screens were damaged or deteriorated. These window(s) may not provide ventilation during months when insects are active. Recommend replacing window screens as necessary.

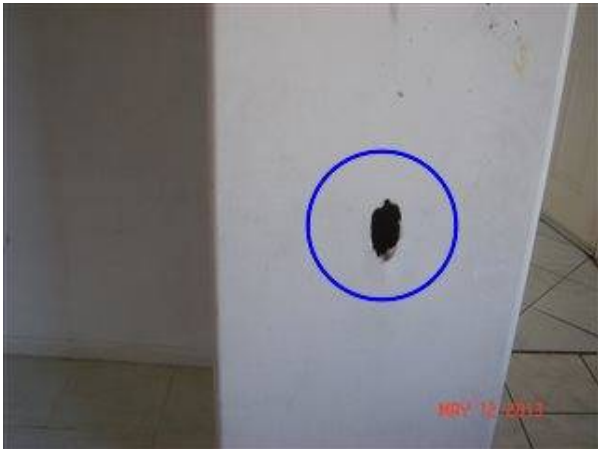
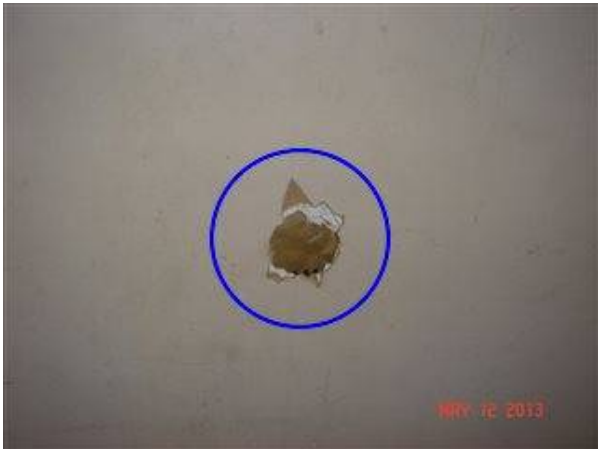
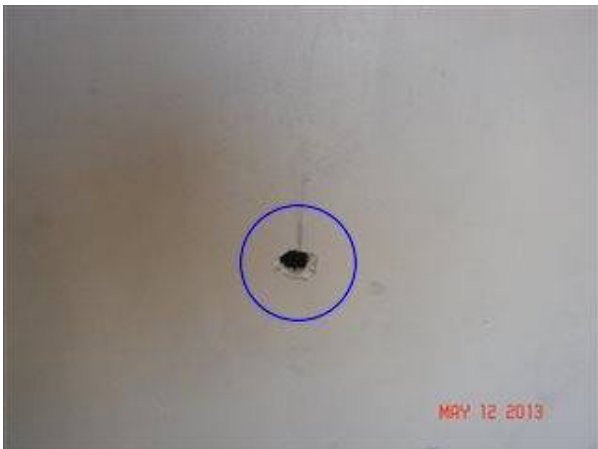
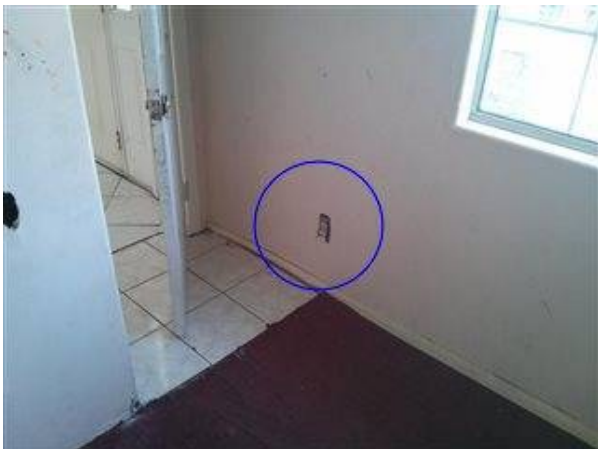
One or more walls were damaged. Recommend that a qualified person repair as necessary.
