Access Building Inspection

Summary

Property address: **14021 Some Road, Anytown, CA90650**

Inspection date: **Sunday, May 12, 2013**

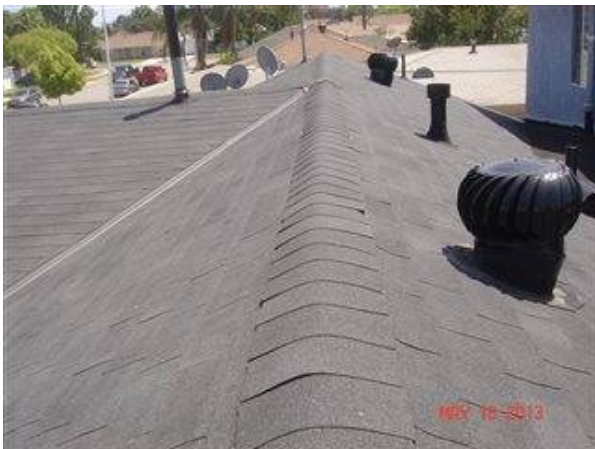
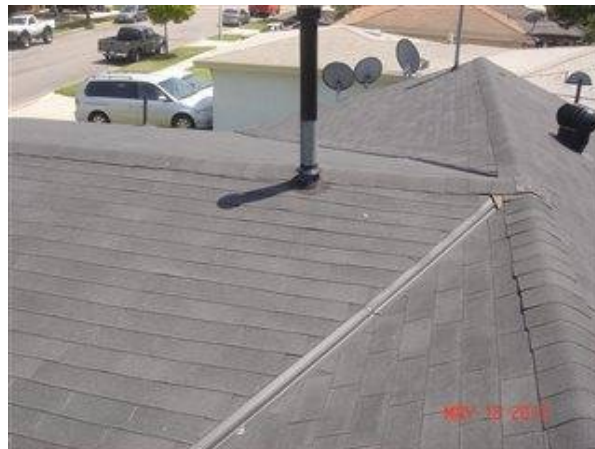
Ridges: The ridge covering material appears to be in serviceable condition.

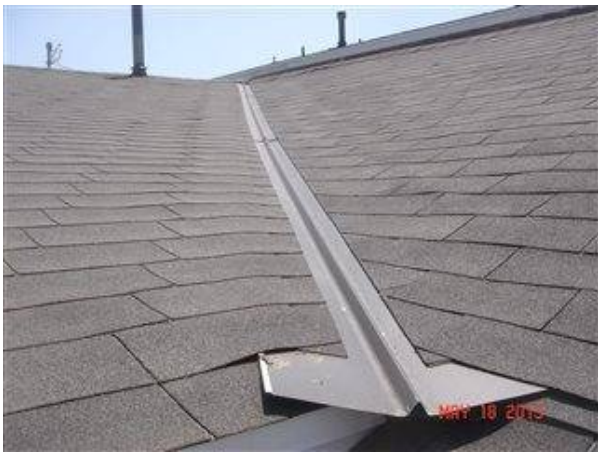
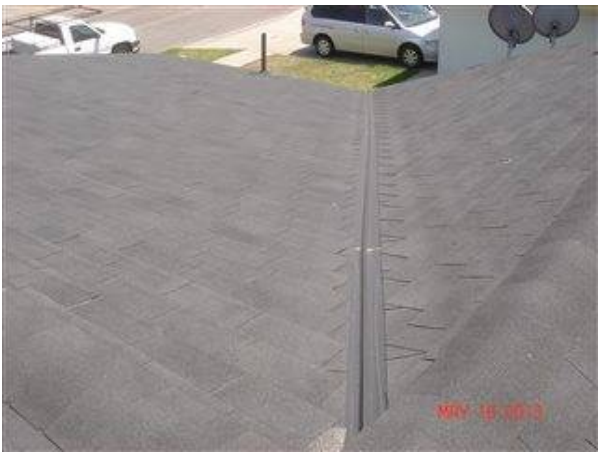
Valley: The valleys on the roof are open with metal valleys.

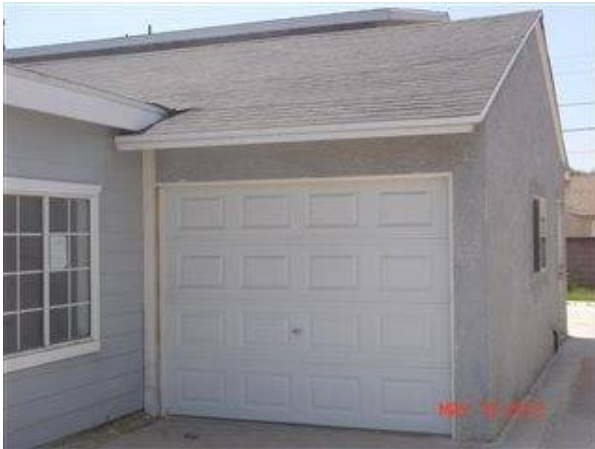
Photo 43

24) ✓ The garage vehicle doors was serviceable.

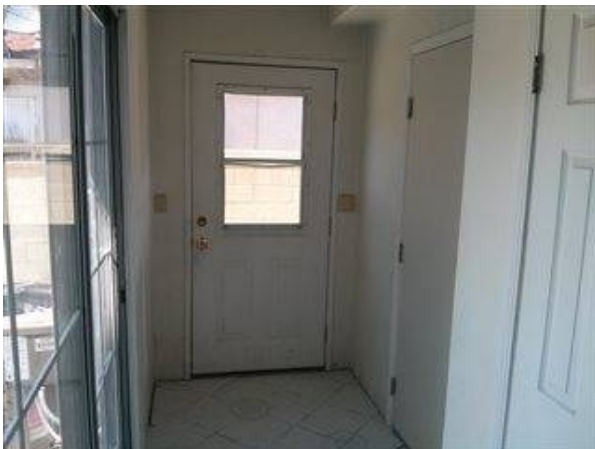
Photo 134

25) ✓ The exterior entry doors was serviceable.

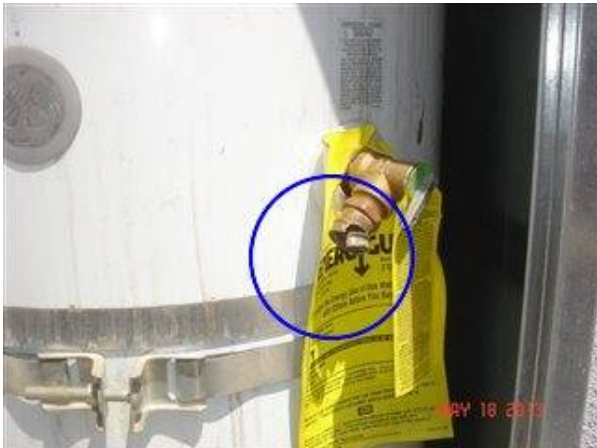
Photo 64

There is no drain line installed TPR valve

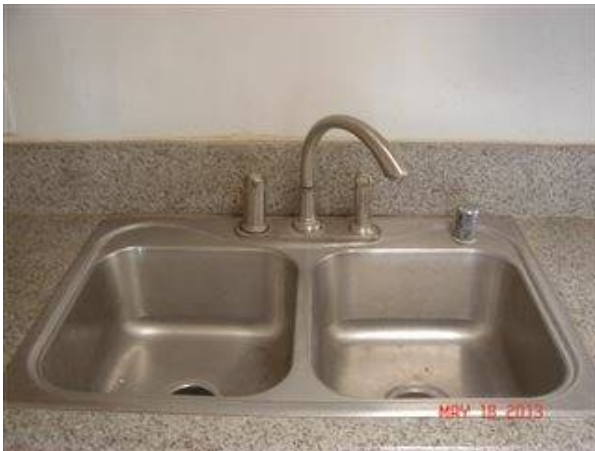
Photo 95

45) ✓ Sink was serviceable.

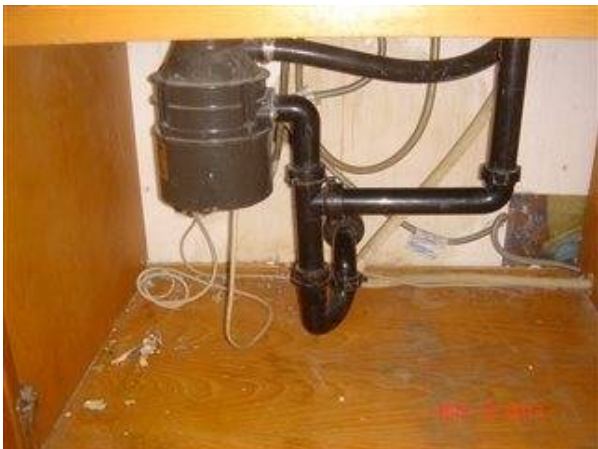
Photo 96

46) ✓ Disposal was serviceable.

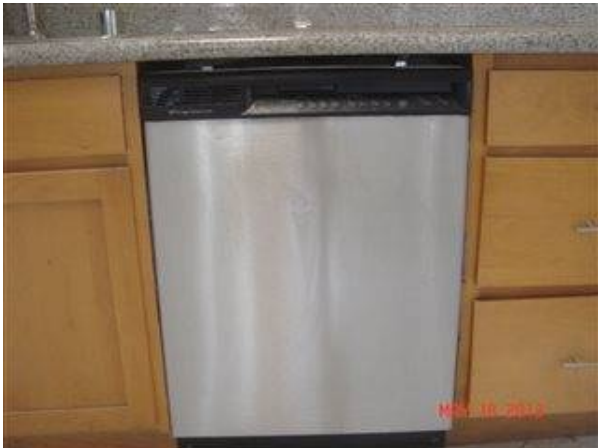
Photo 97

47) ✓ The dishwasher was serviceable.

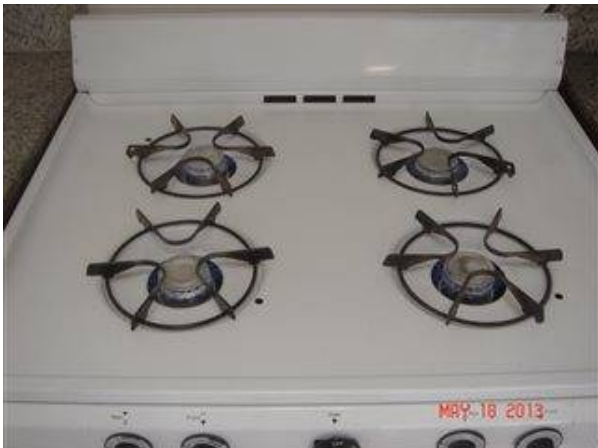
Photo 98

48) ✓ The cooktop and oven was serviceable.

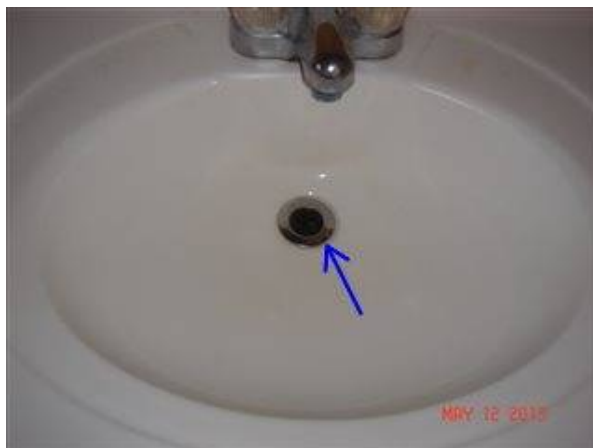
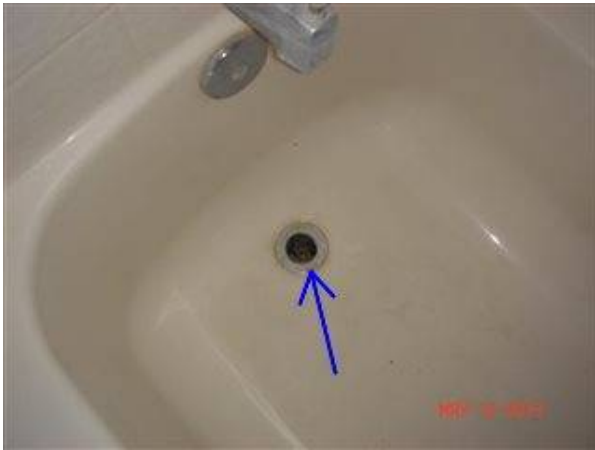
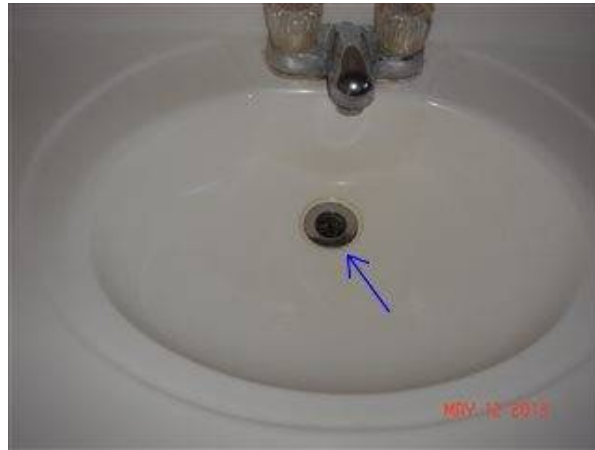
The sink drain stopper mechanism at location(s) #A, D, E, F was missing. Recommend that a qualified person repair or replace as necessary.

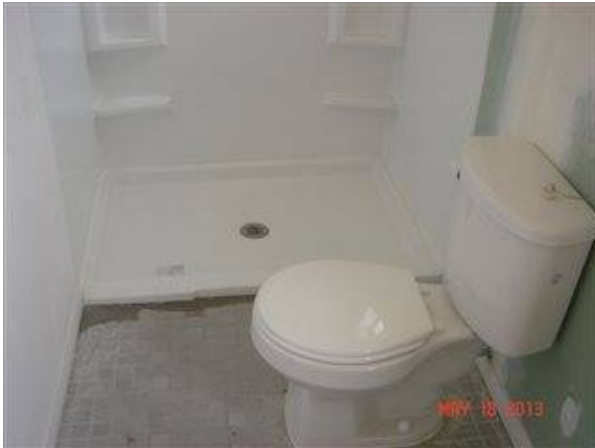
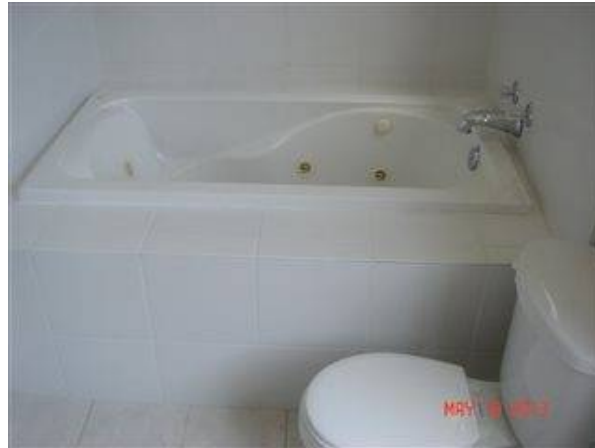
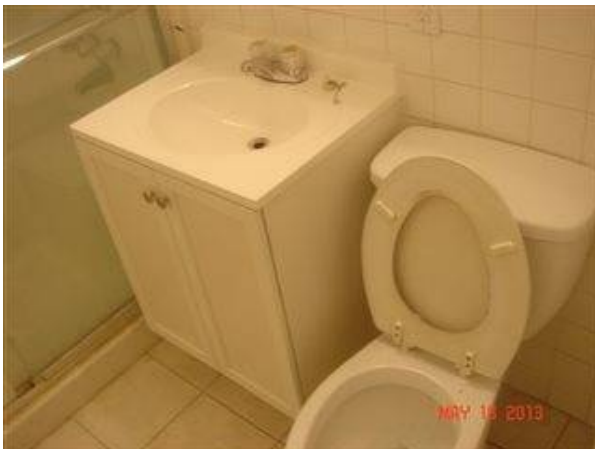
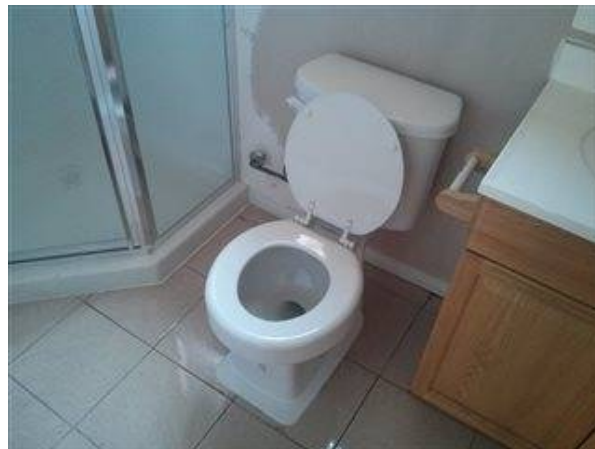
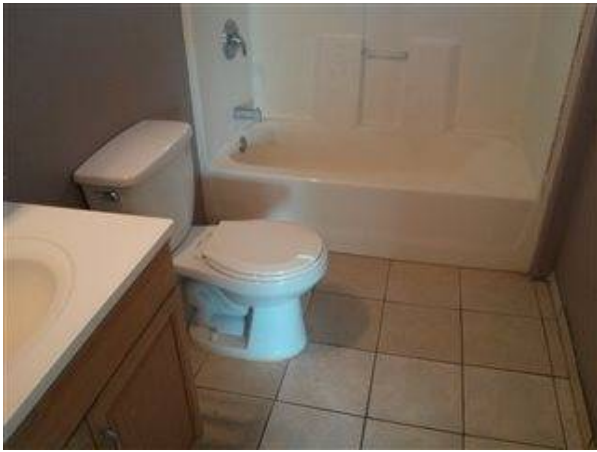
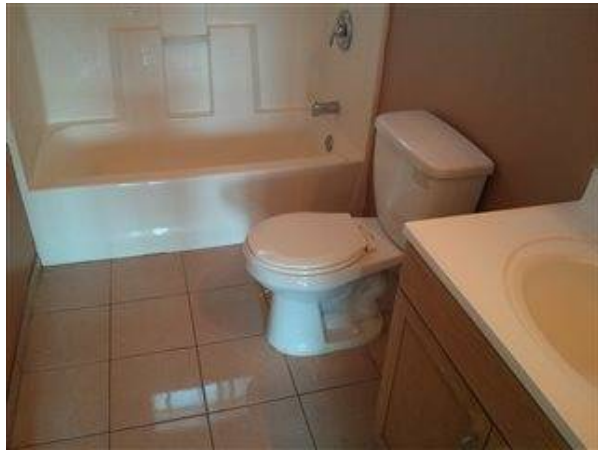
52) ✓ One or more toilets were installed. These are specialty devices and are excluded from this inspection. Comments in this report related to this system are made as a courtesy only and are not meant to be a substitute for a full evaluation by a qualified specialist. Recommend that a qualified specialist evaluate and repair if necessary.

The toilets were serviceable.

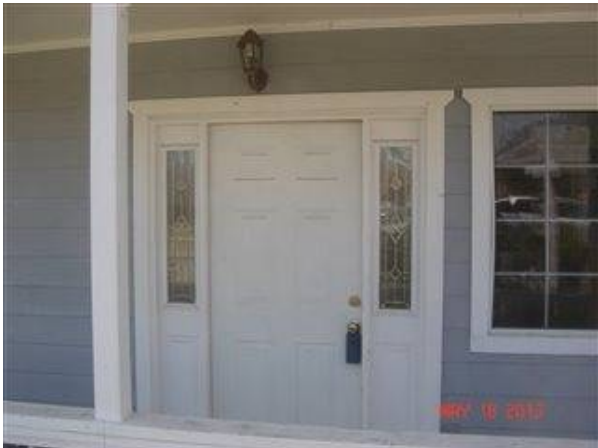
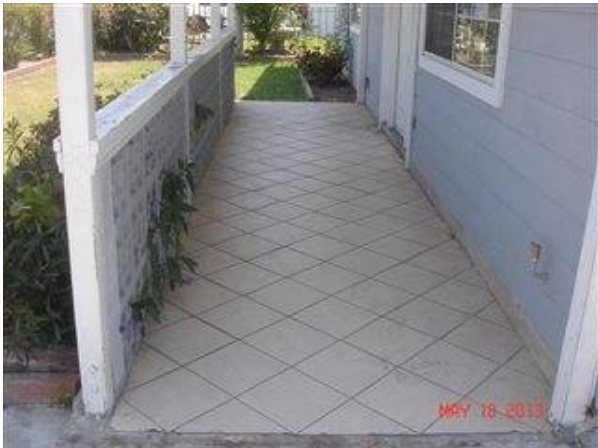
56) ✓ The main entrance door was serviceable.

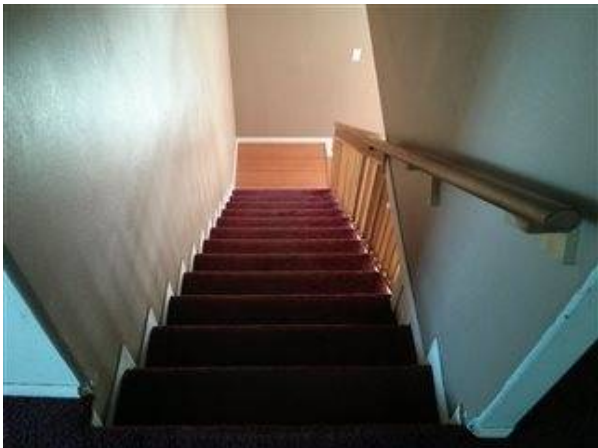
Photo 160

57) ✓ Handrails were servieable.
